# International Journal of Environmental Science

**2-D RESISTIVITY IMAGING AND HYDROGEOCHEMICAL  
ANALYSIS FOR LEACHATE MIGRATION AT DUMPSITES IN  
SOUTH-SOUTH NIGERIA**

Vertical electrical sounding, 2-D tomography and hydrogeochemical analysis was applied to investigate dumpsite leachate plume generation, migration and its impact on the surrounding soil and groundwater aquifer at a municipality in the Western Niger Delta. Twelve vertical electrical sounding (VES) was investigated using the Mini-Res Resistivity Meter with the Schlumberger array. The VES survey result was interpreted with Winglink software. Five hand-dug well water and 5 tap/borehole water samples was collected for hydrogeochemical analysis using the sterile plain bottles and 1-litre plastic bottles. Resistivity results delineated 5 layers of lateritic topsoil, sandy clay, fine coarse-sand, medium coarse-sand and coarse sand. The VES and 2-D tomography mapped and identified 2 distinct zones viz: zone of low resistivity of 91 $\Omega$ m and 394 $\Omega$ m at depth of 5m to >28m indicating area of leachate contaminant plume and zone of high resistivity value of 422 $\Omega$ m and 5102 $\Omega$ m suspected to be dump

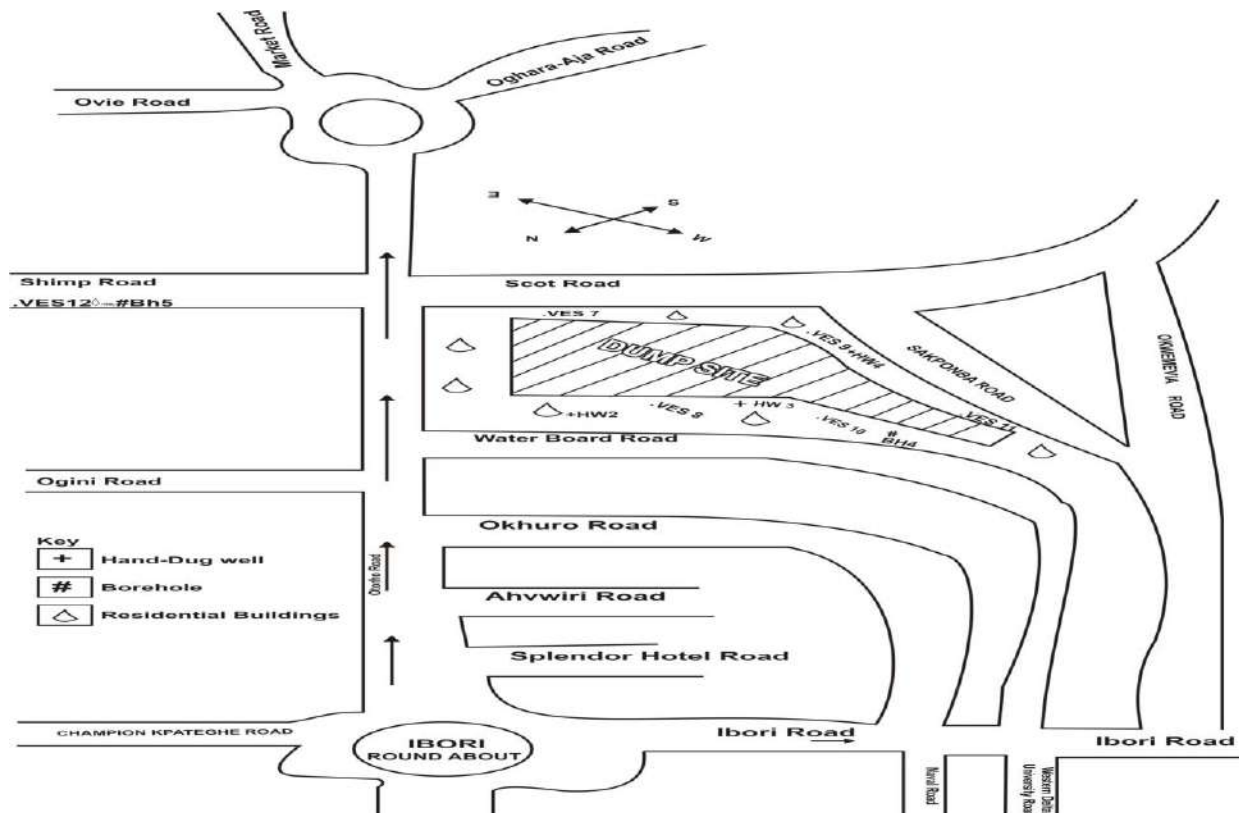
**Figure 3: Map Showing VES Locations at the dumpsite enclosed within Scot and Sakponba Road**

Six VES stations were also run at the Dumpsite enclosed within Scot Road and Sakponba Road (Fig. 3). Four out of the 6 VES (ie VES 7, VES 8, VES 9 and VES 12) were carried out with maximum current electrode spacing AB/2 of 100m and potential electrode separation MN/2 of 10m. VES stations 7, 8 and 9 were each located 10m away from the edge of the dumpsite. The station distance between VES 7, VES 8 and VES 9 was respectively 50m apart. VES 12 which was located along shrimp road was sounded 850m away from the dumpsite at VES station 7. The other 2 VES stations (VES 10 and VES 11) were also carried out on the dumpsite with maximum current AB/2 of 50m and MN/2 of 5m. They were each located 15m away from the beginning of the dumpsite.

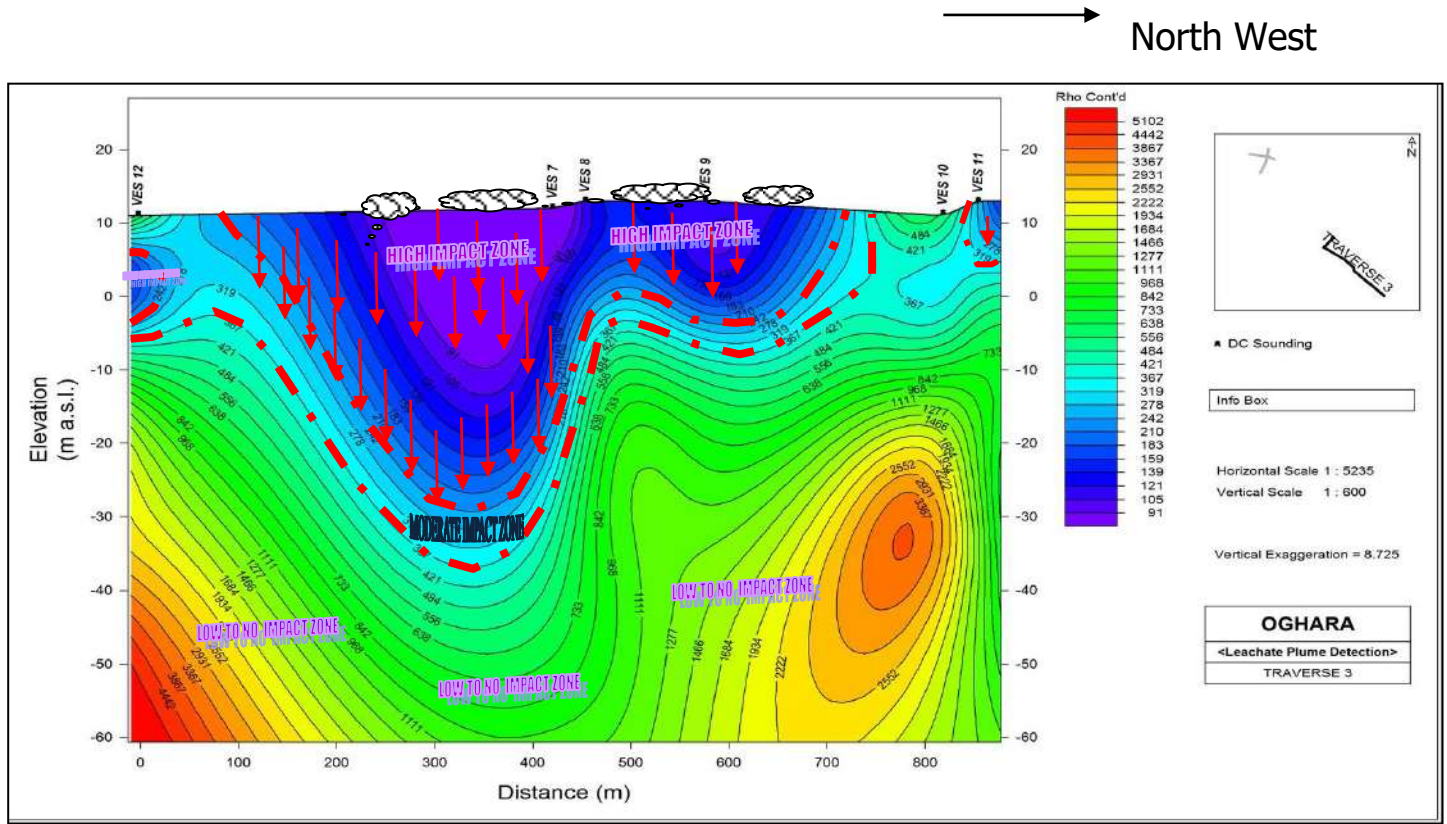
**Figure 7:** The 2-D Section Beneath Profile 3

Profile 3: This profile was done at Ogharefe quarters and it joins VES 7, VES 8, VES 9, VES 10, VES 11 and VES 12 together (Figure 7). It runs in South-East - North-West direction. It has a total length of about 1,482m. This profile consists of series of dumpsites that had existed for well over 50 years. Four zones were delineated beneath this profile. Zone 1 is a low resistivity zone (deep blue/purple colour) with resistivity value ranging from 91  $\Omega$ -m to 242  $\Omega$ -m. This zone is strewn along the entire profile line except around VES 10. The zone is deeper on the southern end of VES 7. It starts from the surface to a depth of 28m, while it extends to 10m under between VES 8 and VES 10. This zone is classified as very high impact zone. Zone 2 is a zone of moderately low resistivity values ranging between 242  $\Omega$ -m and 367  $\Omega$ -m. This resistivity value suggested that this zone had been impacted by the migrating leachate to a depth of 15m and it is classified as high impact zone. The zone forms an oblate shape pointing towards the west, revealing that the leachate is probably migrating towards the east under this profile. The third zone is the zone with resistivity value varying from 247  $\Omega$ -m to 367  $\Omega$ -m, which is classified as moderately impacted zone. Zone 4 is classified as low to no impact zone. This zone forms the flank of the north and the south with the resistivity value varying from 367 Ohm-m to greater than 4442 Ohm-m. The lower end of this range is designated as low impact zone, while the high resistivity value range is classified as no impact zone.

Thus, the 2-D tomography mapped and identified 2 distinct pollutants within and around the dumpsites. These pollutants are compounds of anomalously high resistivities which range between 422 $\Omega$ m and 5102 $\Omega$ m suspected to be dumpsite gases (such as ammonia, methane, sulphur dioxide and carbon dioxide) at depth exceeding 28.7m; and leachate contaminant plumes of low resistivities between 91 $\Omega$ m and 394 $\Omega$ m at depth between 5m to more than 28m.
