# International Journal of Environmental Science

**2-D RESISTIVITY IMAGING AND HYDROGEOCHEMICAL  
ANALYSIS FOR LEACHATE MIGRATION AT DUMPSITES IN  
SOUTH-SOUTH NIGERIA**

**Keywords:** *Aquifer, Dumpsite Leachate, Hydrogeochemical, Tomography*

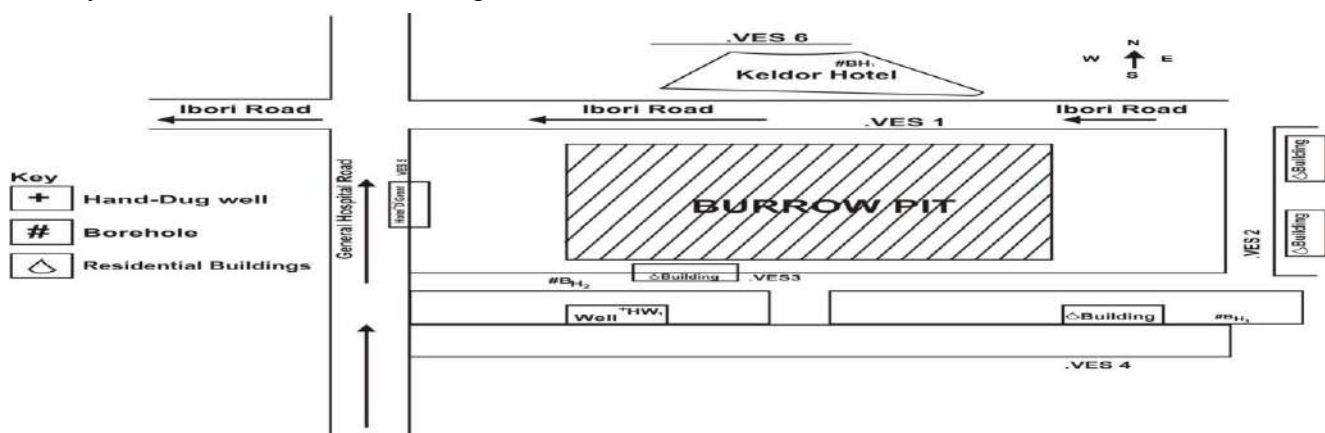
**Figure 2: Map Showing VES Locations at the burrow pit dumpsite**

Six VES stations were carried out at the burrow pit dumpsite. (Fig. 2). VES 1 was located 10m away from the dumpsite on the northern section. VES 2 was carried out with maximum AB/2 of 50m and MN/2 of 5m and located 10m away from the burrow pit dumpsite on the eastern section. VES 3 was located 5m away from the dumpsite on the southern section which was also very close to a residential building (BLD<sub>1</sub>) with borehole (BH<sub>2</sub>). VES 4 which

was sounded 200m away from the dumpsite, but parallel to VES 3 was also located on the southern section of the burrow pit dumpsite. Again, VES 4 was sounded close to a residential building (BLD<sub>2</sub>) with a borehole (BH<sub>3</sub>), and also close to a hand-dug well (HW<sub>1</sub>). VES 5 was located 30m away from the dumpsite on the western section. VES 6 was located 60m away from the dumpsite on the northern section which is parallel to VES 1, but it is behind Keldor hotel with borehole (BH<sub>1</sub>).

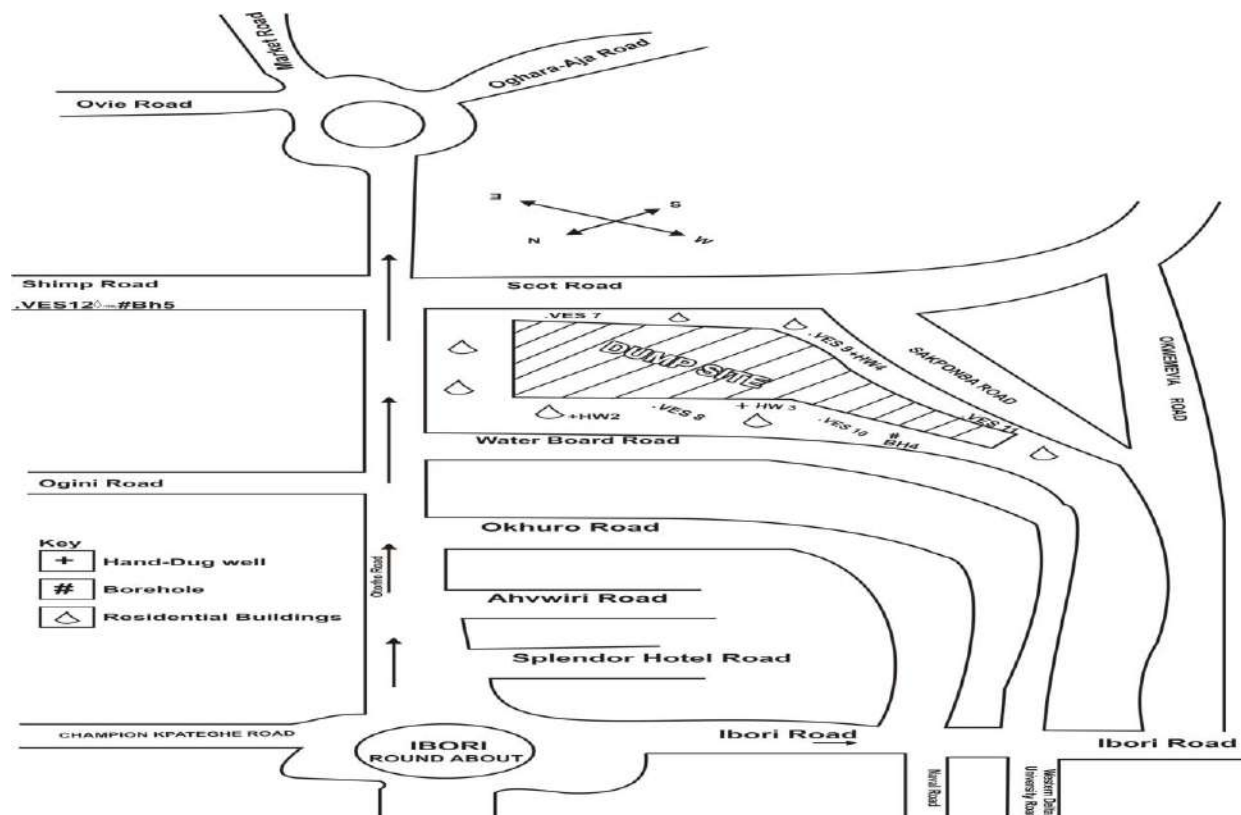
**Figure 3: Map Showing VES Locations at the dumpsite enclosed within Scot and Sakponba Road**

Six VES stations were also run at the Dumpsite enclosed within Scot Road and Sakponba Road (Fig. 3). Four out of the 6 VES (ie VES 7, VES 8, VES 9 and VES 12) were carried out with maximum current electrode spacing AB/2 of 100m and potential electrode separation MN/2 of 10m. VES stations 7, 8 and 9 were each located 10m away from the edge of the dumpsite. The station distance between VES 7, VES 8 and VES 9 was respectively 50m apart. VES 12 which was located along shrimp road was sounded 850m away from the dumpsite at VES station 7. The other 2 VES stations (VES 10 and VES 11) were also carried out on the dumpsite with maximum current AB/2 of 50m and MN/2 of 5m. They were each located 15m away from the beginning of the dumpsite.

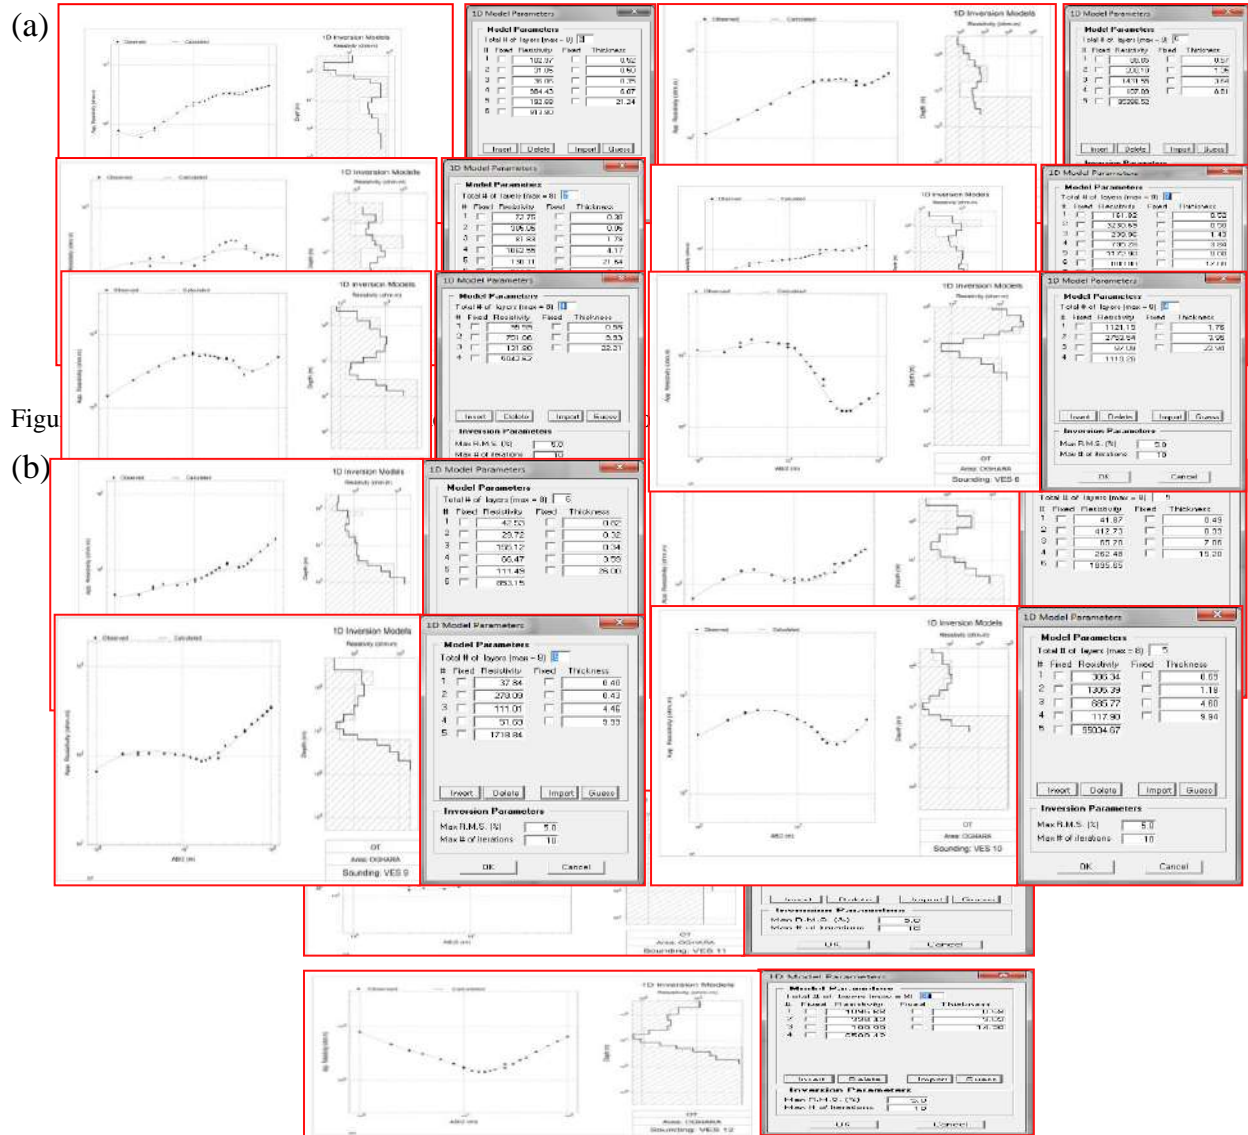
**Figure 4b: VES Stations at the Dumpsite within Scot Road, Sakponba Road and Shrimp Road**

The result of the 1D resistivity survey and the curve types are HKH, KH, KHK, KHA and QH as shown in Figure 4a and 4b. The apparent resistivity values and the corresponding lithology of the 5 delineated layers of lateritic topsoil, sandy clay, fine coarse sand, medium coarse sand, and coarse sand are presented in Table 2. The result of the 2D resistivity survey is divided into 3 profiles as follows:

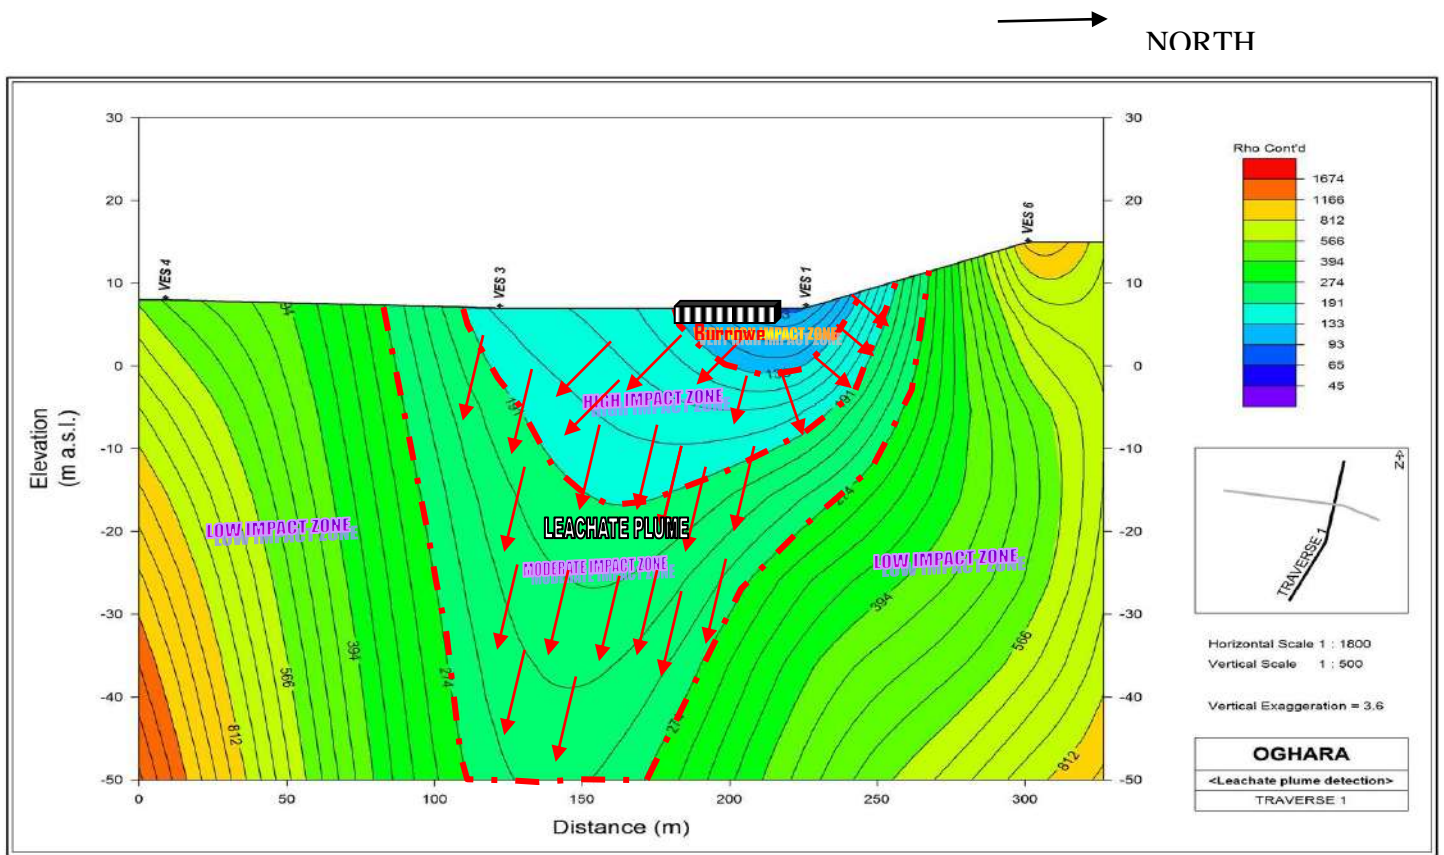
**Figure 5:** The 2-D Section Beneath Profile 1

Profile 1: This profile joins VES 1, VES 2, VES 3 and VES 4 (Figure 5). It runs in North-South direction around the burrow pit dumpsite opposite Keldor hotel. It has a total length of about 290m and a dimension of 20m by 40m. Four zones were delineated beneath this profile. Zone 1 is a low resistivity zone (deep blue colour) with resistivity value ranging from 93  $\Omega$ -m to 133  $\Omega$ -m. This zone is interpreted to be the dumped waste and the generated leachate plume cum the impacted soil. It starts from the surface to a depth of 10m at the middle of the profile. This zone is classified as the very high impact zone. Zone 2 is a zone of moderately low resistivity values ranging between 134  $\Omega$ -m and 191  $\Omega$ -m. This resistivity value suggested that this zone had been impacted by the migrating leachate to a depth of 15m. It is classified as high impact zone and forms an oblate shape pointing towards the south, revealing that the leachate is probably migrating towards the south under this profile. Zone 3 is the zone with resistivity value varying from 192  $\Omega$ -m to 274  $\Omega$ -m, this zone is classified as moderate impact zone. Zone 4 is classified as low to no impact zone as it forms the flank of the north and the south with the resistivity value varying from 274 Ohm-m to greater than 812 Ohm-m. The lower end of this range is designated as low impact zone, while the high resistivity value range is classified as no impact zone.

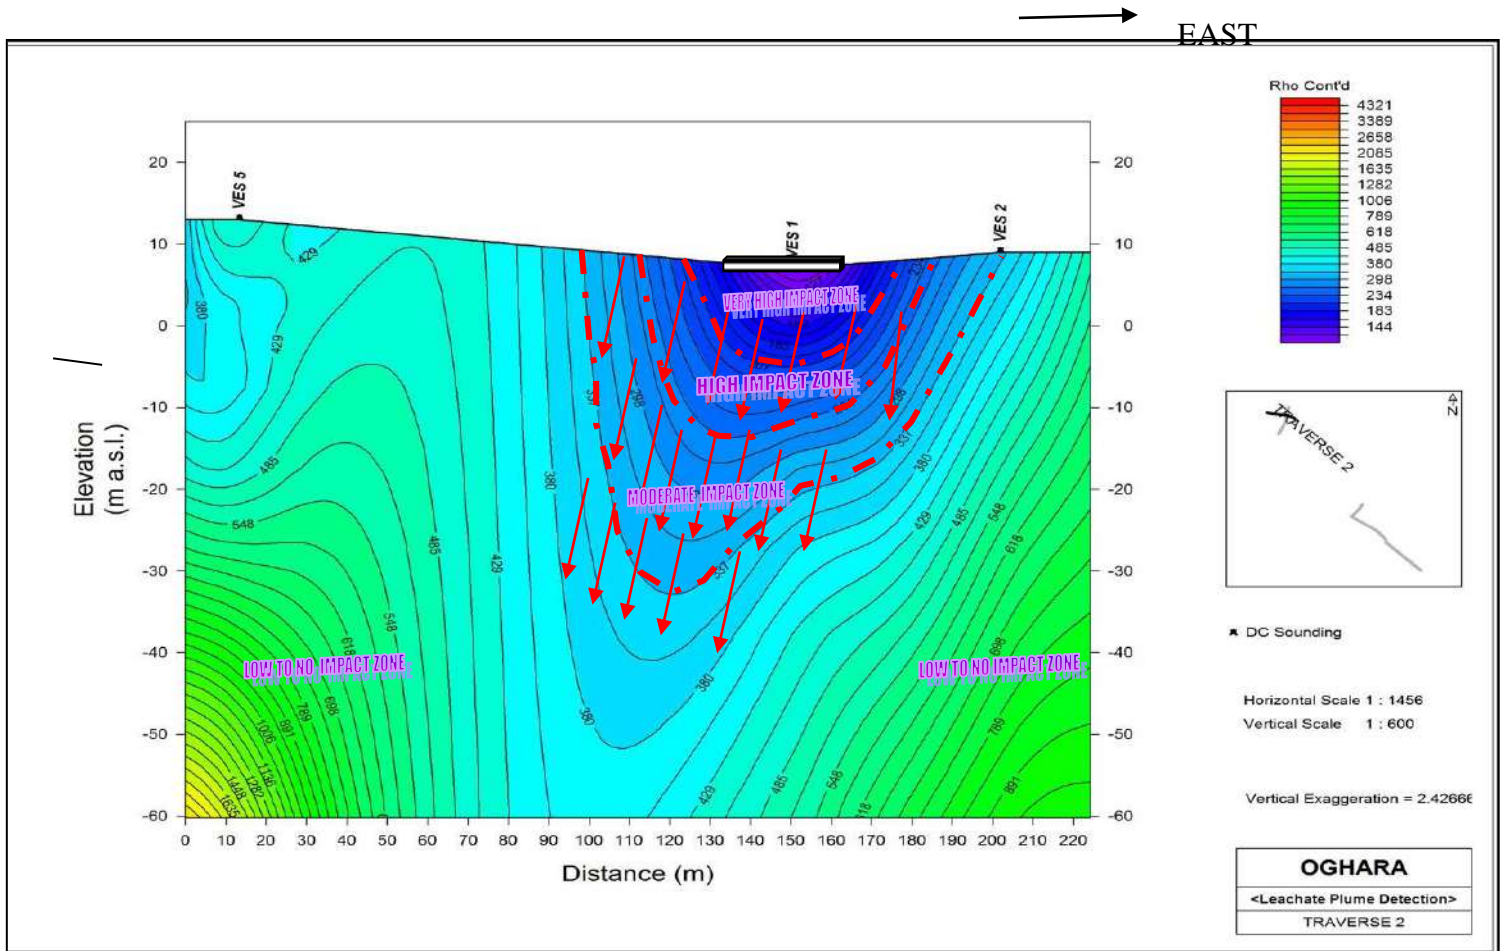
**Figure 6:** The 2-D Section Beneath Profile 2

Profile 2: This profile joins VES 5, VES 1 and VES 2 together (Figure 6). It runs in East-West direction around the burrow pit dumpsite opposite Keldor hotel. It has a total length of about 200m. Four zones were delineated beneath this profile. Zone 1 is a low resistivity zone (deep blue colour) with resistivity value ranging from 100  $\Omega$ -m to 207  $\Omega$ -m. This zone is interpreted to be the dumped waste and the generated leachate plume cum the impacted soil. It starts from the surface to a depth of 5m at the middle of the profile. This zone is classified as very high impact

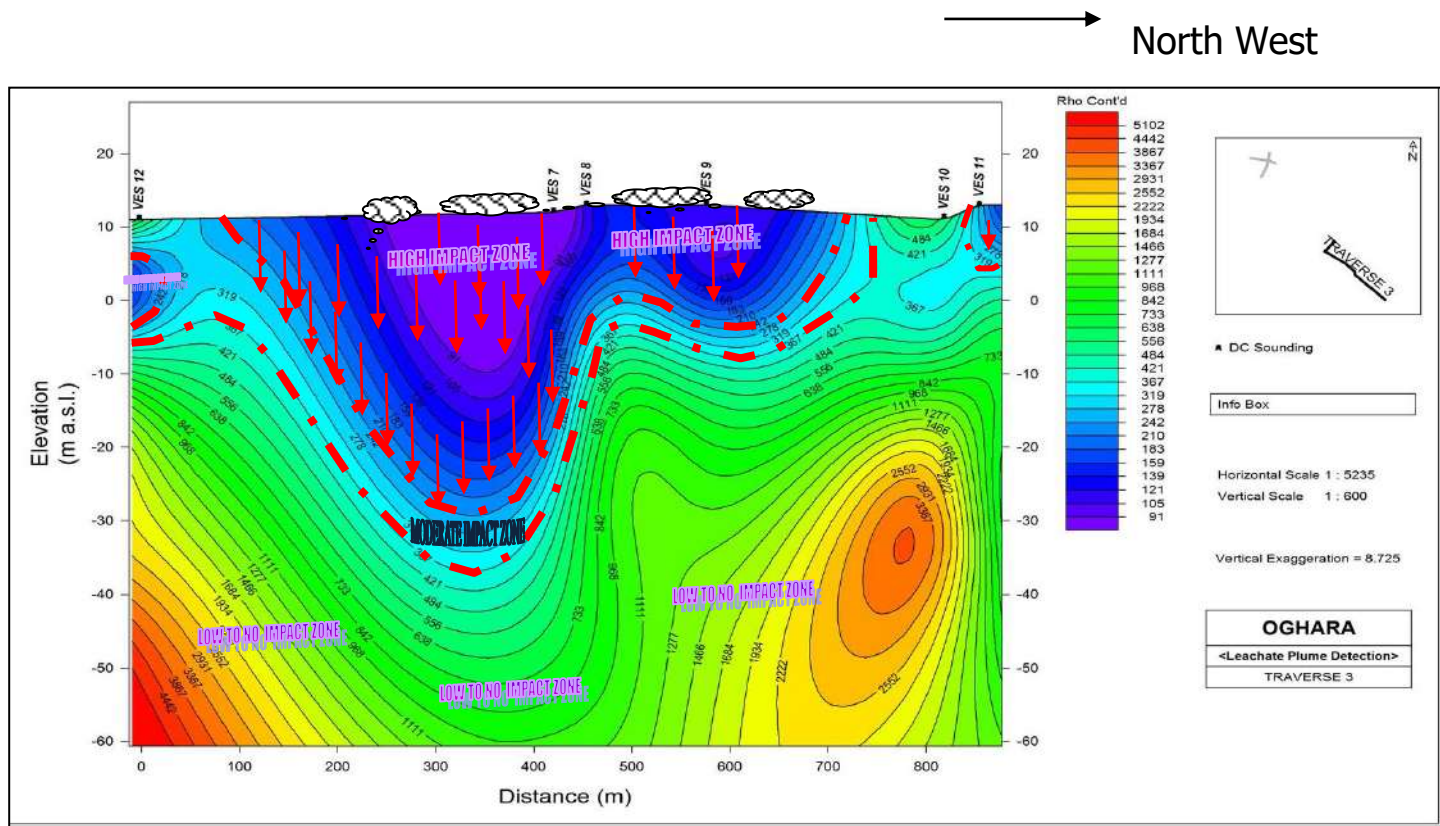
**Figure 7:** The 2-D Section Beneath Profile 3

Profile 3: This profile was done at Ogharefe quarters and it joins VES 7, VES 8, VES 9, VES 10, VES 11 and VES 12 together (Figure 7). It runs in South-East - North-West direction. It has a total length of about 1,482m. This profile consists of series of dumpsites that had existed for well over 50 years. Four zones were delineated beneath this profile. Zone 1 is a low resistivity zone (deep blue/purple colour) with resistivity value ranging from 91  $\Omega$ -m to 242  $\Omega$ -m. This zone is strewn along the entire profile line except around VES 10. The zone is deeper on the southern end of VES 7. It starts from the surface to a depth of 28m, while it extends to 10m under between VES 8 and VES 10. This zone is classified as very high impact zone. Zone 2 is a zone of moderately low resistivity values ranging between 242  $\Omega$ -m and 367  $\Omega$ -m. This resistivity value suggested that this zone had been impacted by the migrating leachate to a depth of 15m and it is classified as high impact zone. The zone forms an oblate shape pointing towards the west, revealing that the leachate is probably migrating towards the east under this profile. The third zone is the zone with resistivity value varying from 247  $\Omega$ -m to 367  $\Omega$ -m, which is classified as moderately impacted zone. Zone 4 is classified as low to no impact zone. This zone forms the flank of the north and the south with the resistivity value varying from 367 Ohm-m to greater than 4442 Ohm-m. The lower end of this range is designated as low impact zone, while the high resistivity value range is classified as no impact zone.
