# Geoelectric and Geochemical Assessment of Sub-Soil Corrosivity and Competence for Civil Infrastructures at Utue-Ogume, Delta State, Nigeria

## Research Article

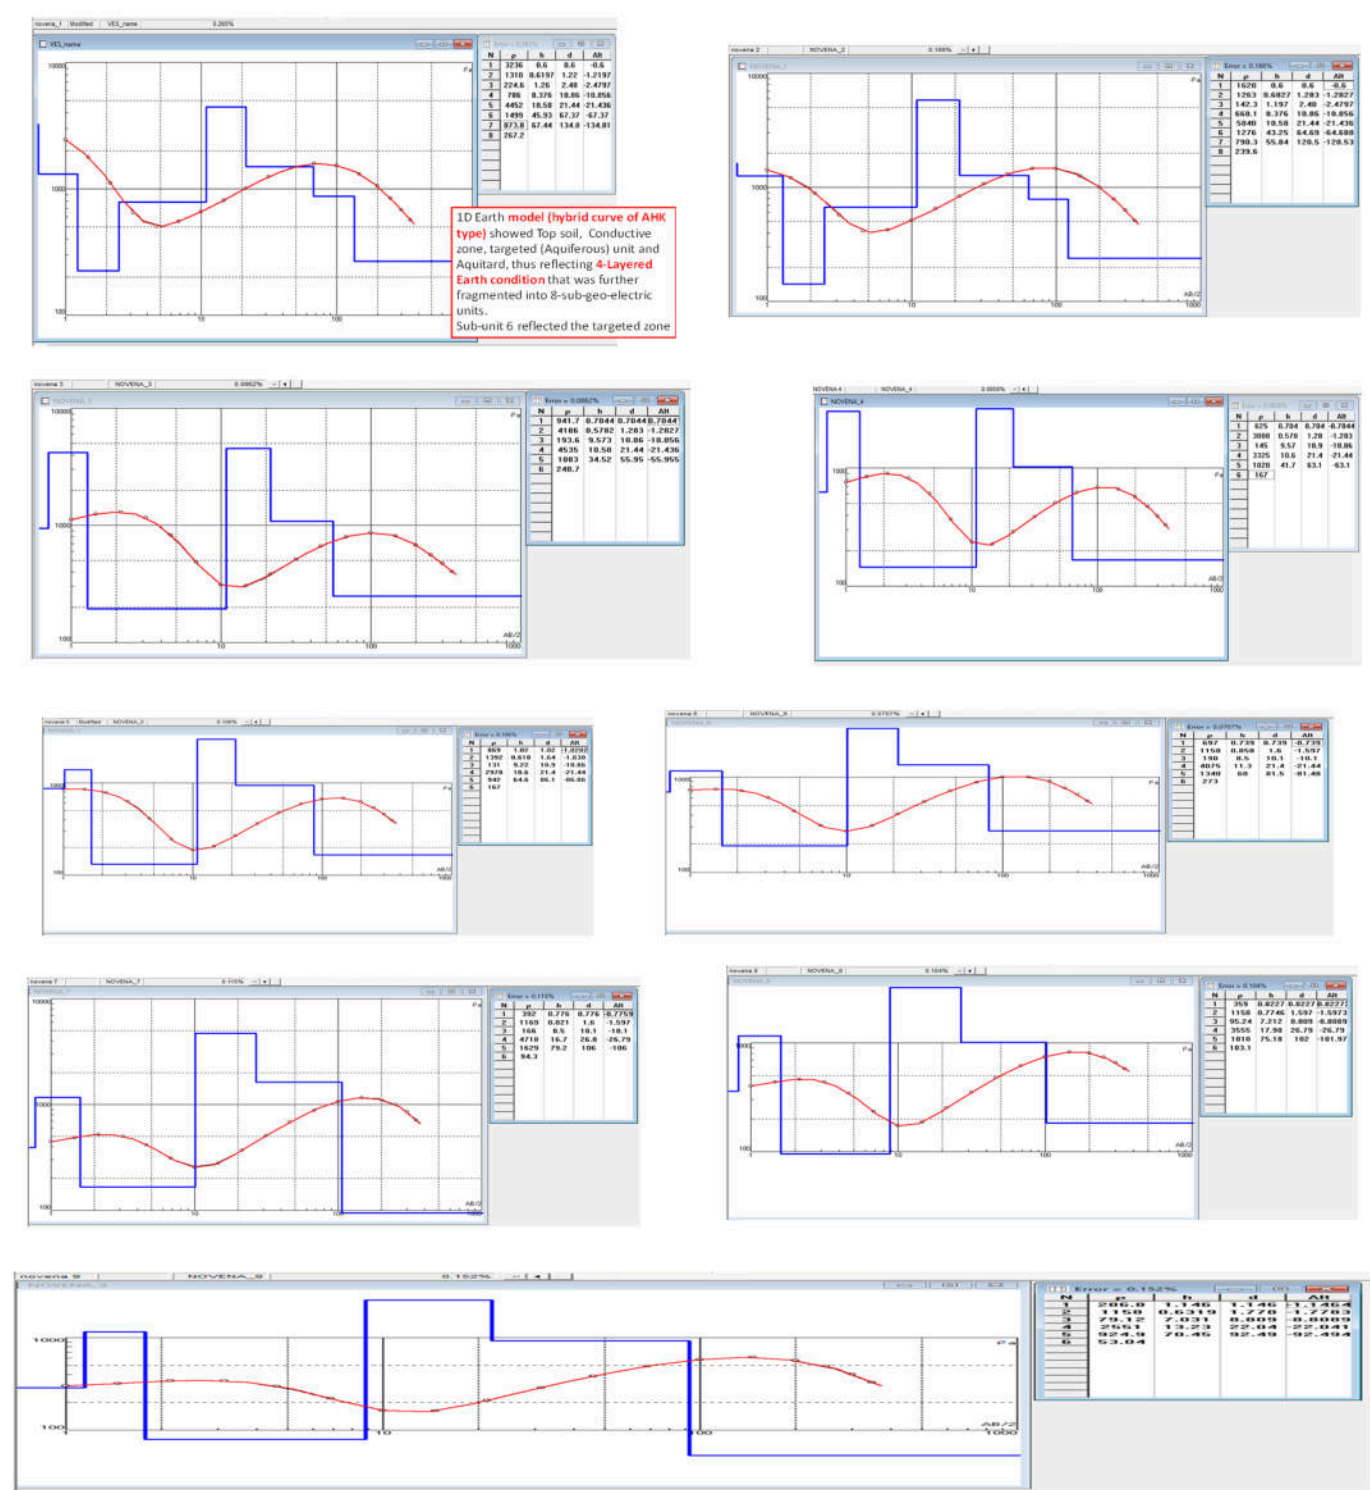
Figure 2

VES Field Curves of the 1-D Resistivity Model

The number of subsurface layers at each VES data station was identified from the results of the geoelectric curves. The area consists of HK curve types (Fig. 2). The obtained VES curves delineated six to eight geoelectric heterogeneous layers of lateritic topsoil, clayey sand, sandy clay, Fine to medium grained sand, medium to coarse grained sand, coarse grained sand, sandy clay and clay (Table 1). The resistivity, thickness and depth of the area varied respectively from 53.04Ωm (VES 9) to 4,535Ωm (VES 3), 0.6m (VES 1 and VES2) to 79.2m (VES 7), and 0.6m (VES 1 and VES 2) to 134.8m (VES 1).

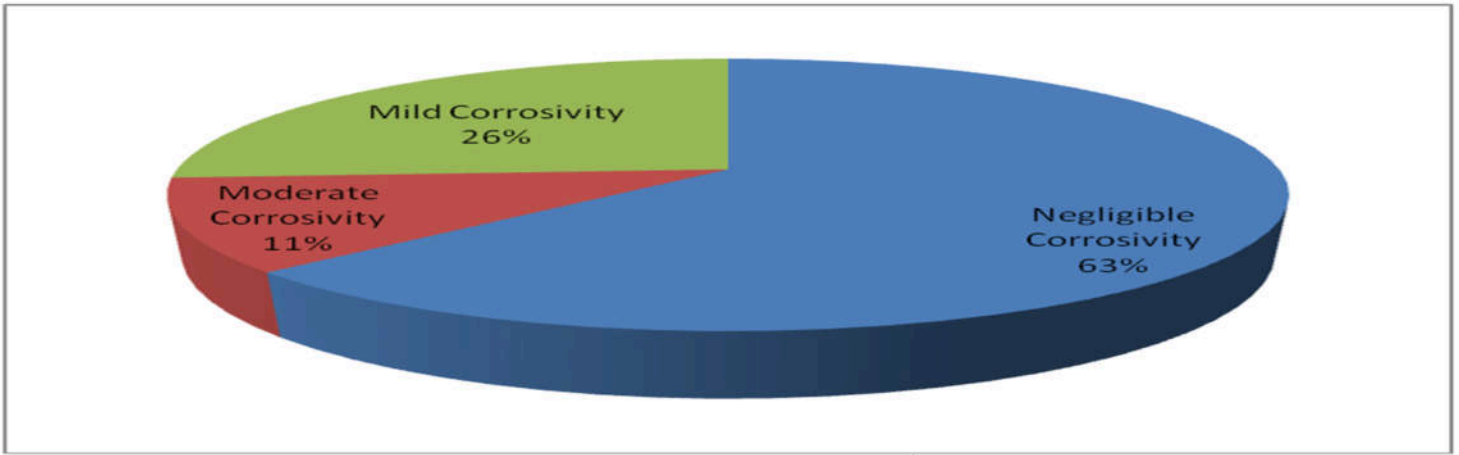
**Figure 3**

Percentage of Subsoil Corrosivity Rating with Geochemical Parameters

The sulphate concentration in the soil varied from 126.8ppm to 276.9ppm with a mean concentration value of 203.79ppm. These range of sulphate concentration values in the soil were observed to be lower (Table 2) than the recommended permissible limit of 1000ppm [40, 41]. However, although the sulphate concentration values are lower than permissible standard for soil, a comparison of the sulphate concentration values to the corrosivity rating by [39] as highlighted in Table 2 and Table 4 revealed that the sulphate concentration in the soil to a depth of 3m at all the VES stations are in the classification of mild to moderate corrosivity. Therefore the soil at that depth is a potential threat to buried metallic pipes with time if not properly contained or treated. 63% of the first and second subsoil layers in the area were characterized as negligible corrosivity while 26% and 11% of the third subsoil layers in the area were respectively characterized as mildly corrosive and moderately corrosive when rated with geochemical parameter values (Table 4 and Fig. 3).

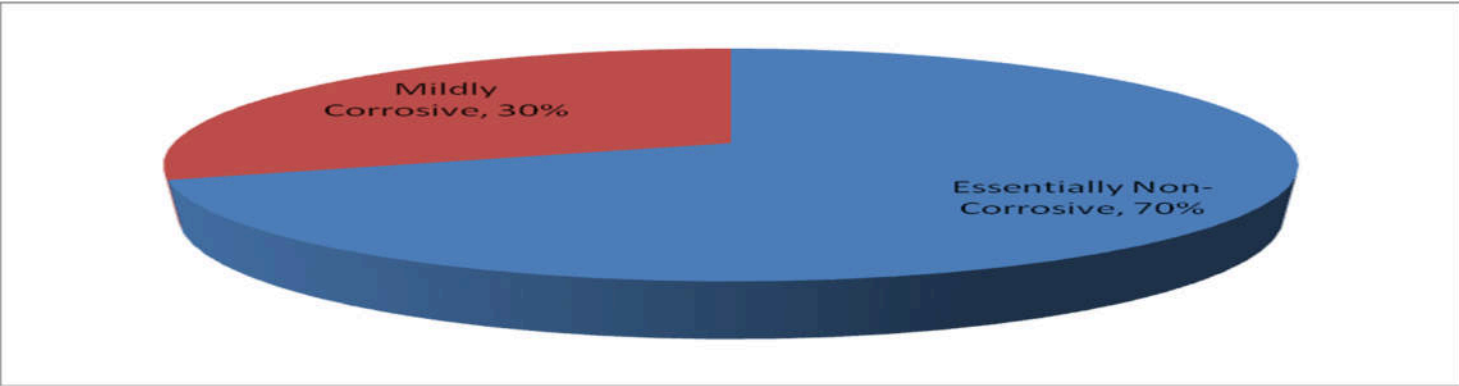
**Figure 4**

Percentage of Subsoil Corrosivity Rating with Resistivity Data

Since corrosive soils are aggressive to concrete, water reticulation pipes and crude oil/gas buried pipelines, the corrosive nature of the soil was investigated to depth of 3m. This depth was chosen because the minimum recommended depth of burial for water pipelines, crude oil and gas pipelines, and foundation footings of civil engineering structures is to approximately 1.0 meters (3 feet) [1], [3–5]. The first, second and third layer resistivity values at the nine VES stations which was to a depth of over 2m was used to investigate the soil corrosivity in the study area. The inferred lithology obtained while drilling with the hand auger was assigned to the first, second and third layer resistivity and was compared to the corrosivity rating by [42] and [43] (Table 5). The soils in this area can therefore be classified into essentially non-corrosive and mildly corrosive (Table 6). This classification is in agreement with the geochemical parameters classification (Table 2) of mildly, moderately and negligible corrosivity. The essentially non-corrosive nature of the soil to a depth range of 1m to 2m was observed in the first and second resistivity layers at all the VES stations (VES 1 to VES 9). However, a corrosivity classification inversion to mildly corrosive nature of the soil was observed from depth 2m and above in the third resistivity layer at VES 2 to VES 9. Hence, the use of steel pipes to transport crude oil and gas and for water pipelines reticulation should be buried to a restricted depth of 1.0m which is the layer of non-corrosive soil. Civil infrastructure foundation footings should also be done to a depth of 1.0m of essentially non-corrosive soil since the soil materials at this depth would not be aggressive to concrete foundation footings or metallic engineering works in the area. Care should also be taken not to bury crude oil/gas pipelines, water pipelines and foundation footings of civil infrastructures to a depth beyond 2m as it would respectively result in crude oil/gas and water pipelines leakage as well as in the collapse of civil infrastructures. The soil beyond 2m depth would aggressively attack buried metallic pipes and concrete. The non-corrosive and mildly corrosive nature of the soils at the nine VES locations is highlighted in Table 6 and Fig. 4.

On the basis of subsoil resistivity values and inferred lithology at the VES stations, the study revealed that 67% of the first and second subsoil layers at VES 1 to VES 9 was rated essentially non-corrosive, 3% of the third subsoil layer at VES 1 was also rated essential non-corrosive, while 30% of the third subsoil layer at VES 2 to VES 9 was rated as mildly corrosive. Again, 15% of the first subsoil layer at VES 4, VES 6, VES 7 and VES 8 was rated competent in the area. 19% of the first sub-subsurface layers at VES 1, VES 2, VES 3, VES 5 and VES 9 was also rated highly competent to withstand overburden stress from civil engineering infrastructures. Moreover, 33% of the second subsoil layer at VES 1 to VES 9 was rated highly competent to withstand overburden stress while 33% of the third subsoil layer was rated moderately competent at VES 1 to VES 9. These are highlighted in Fig. 5. It was observed that the subsurface layers of competent and highly competent soils are characterized by high resistivity values which also correspond to essentially non-corrosive soil having almost neutral pH values, low chloride and sulphate values to a depth range of 0.6m to 1.7m. This layer and depth is good for erecting massive civil engineering infrastructures and would withstand the structures overburden weight on the soil thereby avert collapse of such structures. While the subsurface layers of moderate competent soil are characterized by lower resistivity values than those of competent soils and correspond to mildly

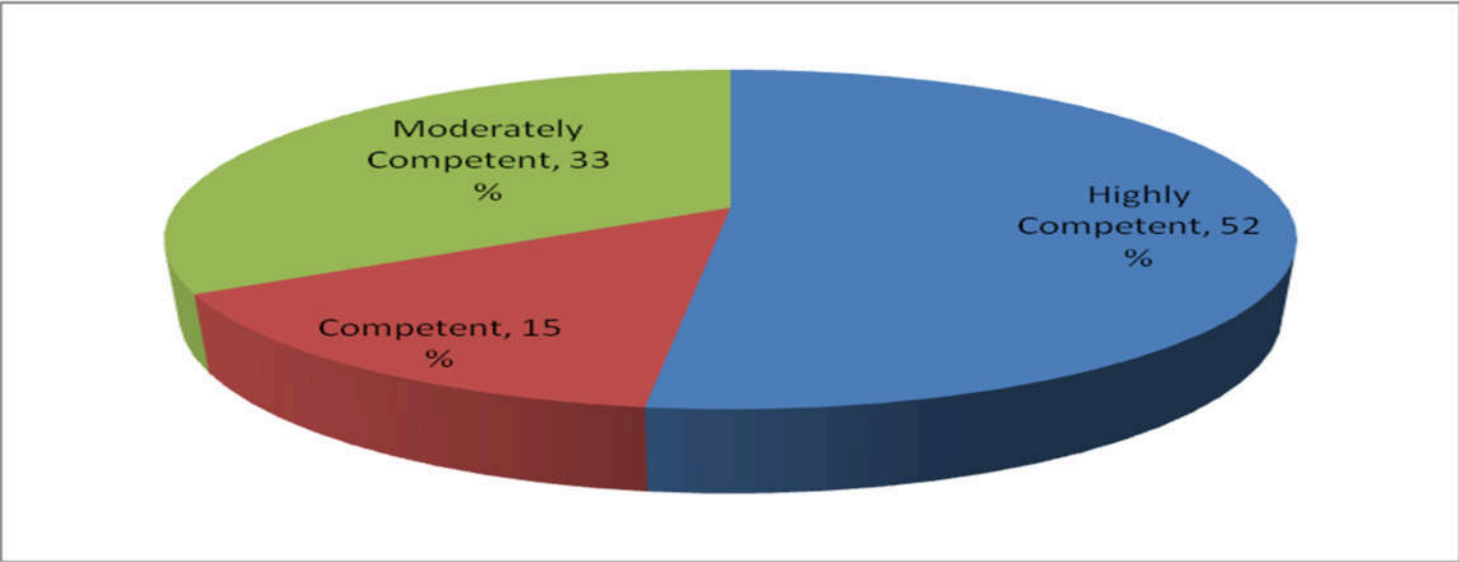
**Figure 5**

Percentage of Subsoil Competence Rating with Resistivity Data
